#### UNITED STATES ENVIRONMENTAL PROTECTION AGENCY

Re: Notice of Violation Compliance Evaluation Inspection ILD 054 236 443

On March 5-9, 2018, representatives of the U.S. Environmental Protection Agency inspected the 3M Company (3M) located in Cordova, Illinois. As a large quantity generator of hazardous waste, 3M is subject to the Resource Conservation and Recovery Act, 42 U.S.C. § 6901 *et seq.* (RCRA). The purpose of the inspection was to evaluate 3M's compliance with certain provisions of RCRA and its implementing regulations related to the generation, treatment and storage of hazardous waste. A copy of the inspection report is enclosed for your reference.

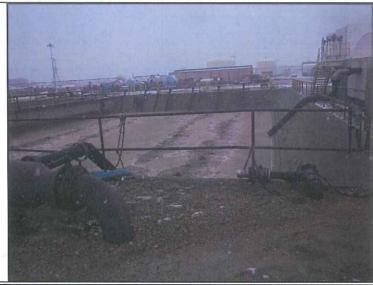
Attributes		
Photo Number	1	
File Name	RIMG0089.JPG	
Date/Time	3/6/2018 8:35:16 AM	
Photographer	C. Lutz	
Description	Aerobic digester at the wastewater treatment plant

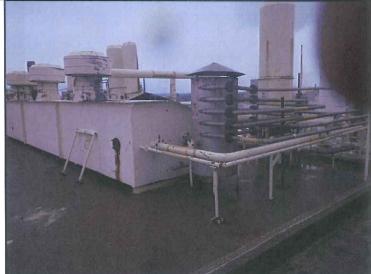
Building 3's vent tanks discharge to blowdown tanks. Some process vents from building 3 vent to the atmosphere. Each blowdown tank receives liquids from two vent tanks, for a total of four blowdown tanks (and eight vent tanks) on the roof of building 3. The blowdown tanks are open to the atmosphere, but have a roof-like cover. The blowdown tanks also collect material if a reactor's rupture disk releases material. 3M personnel stated that the liquid in the blowdown tanks is mostly water. Blowdown tanks B5 and B7 were drained on September 9, 2017. On February 23, 2018, blowdown tank B3 was identified as needing cleaning (Appendix G)

Attributes		
Photo Number	2	
File Name	RIMG0090.JPG	
Date/Time	3/6/2018 9:18:32 AM	
Photographer	C. Lutz	
Description	Building 3 roof - vent tank (silver) that discharges into blowdown tanks

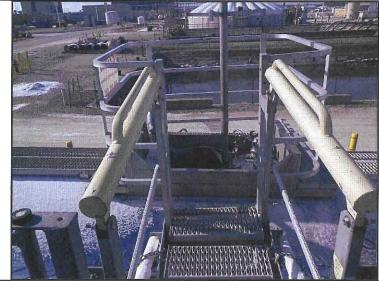
At the time of the inspection, 3M had two tanker trucks holding spent solvent with open hatches while no one was adding to or removing waste from the containers. One open hatch was observed in building 18 with a reading of 12,000 ppm using the Thermo Scientific toxic vapor analyzer 1000B (TVA). The second open hatch was observed in building 16 with a reading of 6,000 ppm using the TVA.

(1) The waste is placed in or one of the following types of unites and the generator complies with the applicable requirements:	NEIC inspectors observed an open hatch on a tanker truck that was being filled in the building 18 solvent handling area (Appendix A, photo 10, and Appendix D). A reading of 12,000 ppm was observed. There was material in the tanker,	Appendix D – FLIR Video  Appendix E – 3M's March	
1100	(A) In containers and the generator complies with the applicable requirements of subparts I, AA, BB, and CC of 35 IAC Code 725	and the 3M employee (Bill Conner) responsible for the filling operations was not in the area. B. Conner later joined the inspection team and 3M personnel and stated that he was filling the tanker but was called away. He said it typically takes about	23, 2018, Email  Appendix F – FLIR Video	
	35 LAC §725.987(d)(3) [40 CFR §265.1087(d)(3)] — Whenever a hazardous waste is in a container using Container Level 2 controls, the owner or operator shall install all covers and closure devices for the container, and	8 hours to fill a tanker truck. NEIC inspectors requested a copy of the "fill sheet" detailing what was going into the tanker. 3M's March 23, 2018, email states that a fill sheet could not be located (Appendix E).

Attributes	
Photo Number	10
File Name	RIMG0098.JPG
Date/Time	3/7/2018 9:10:11 AM
Photographer	L. Goodnight
Description	Building 18 area - tanker with open hatch

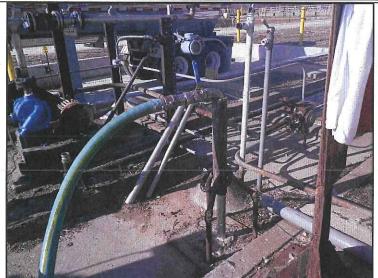
Attributes	
Photo Number	11
File Name	RIMG0099.JPG
Date/Time	3/7/2018 9:12:38 AM
Photographer	L. Goodnight
Description	Building 18 fill hose

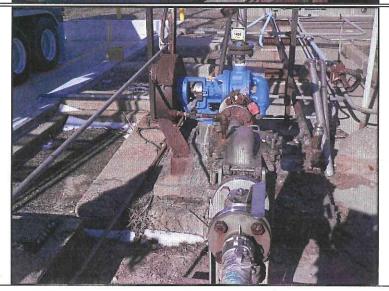
DRAFT			
5	35 IAC § 725.956(a)(1) [40 CFR §265.1056(a)(1)] – Each open-ended valve or line shall be equipped with a cap, blind flange, plug, or a second valve.	During the Subpart BB comparative monitoring, NEIC inspectors observed four open-ended valves that were not equipped with a cap, blind flange, plug, or second valve.	Appendix A - NEIC Photographs, Photos 11, 12, 13 and 16	
		3M personnel corrected the open-ended lines during the inspection. NEIC inspectors observed the first two open-ended lines in the building 18 solvent handling area: one on a filter (Appendix A, photos 12 and 13) and one on a dip pipe (Appendix A, photo 11), with a 6,000 parts per million (ppm) reading from the TVA. The other two open-ended lines were observed in building 20: one on the first floor (Appendix A, photo 16), and one the second floor.		
6	35 IAC § 722.134 (a) {[40 CFR §262.17(a)(1)(i)]a generator may accumulate hazardous waste on-site for 90 days or less without a permi provided that:	During LDAR monitoring, on March 7, 2018, NEIC inspectors observed two open hatches on tanker trucks that contained waste solvent.	Appendix A – NEIC Photographs, Photos 10 and 17

Attributes	
Photo Number	12
File Name	RIMG0100.JPG
Date/Time	3/7/2018 9:13:20 AM
Photographer	L. Goodnight
Description	Building 18 area - open-ended line off filter

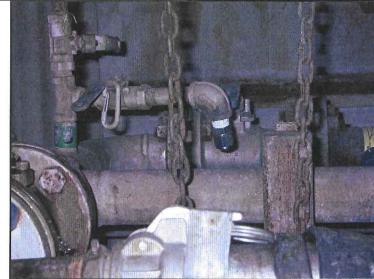
Α	ttributes				
Photo Number	16				
File Name	RIMG0104.JPG 3/7/2018 10:10:22 AM				
Date/Time					
Photographer	L. Goodnight				
Description	Building 20, first floor open-ended line

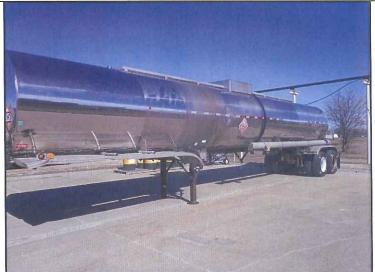
At the time of the inspection 3M was accumulating hazardous waste in one container without the words "Hazardous Waste." The container was a tanker trailer containing spent solvent located in building 18's less than 90-day hazardous waste storage area.

Attributes				
Photo Number	20			
File Name	RIMG0108.JPG			
Date/Time	3/8/2018 2:13:34 PM			
Photographer	L. Goodnight			
Description	Building 18 tanker with no hazardous waste label

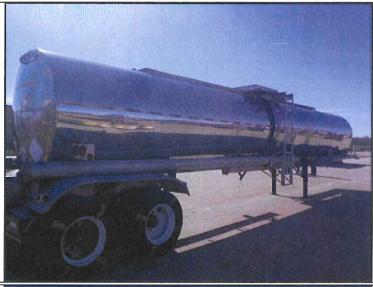
Attributes					
Photo Number	22				
File Name	RIMG0110.JPG 3/8/2018 2:14:20 PM				
Date/Time					
Photographer	L. Goodnight				
Description	Building 18 tanker with no hazardous waste label

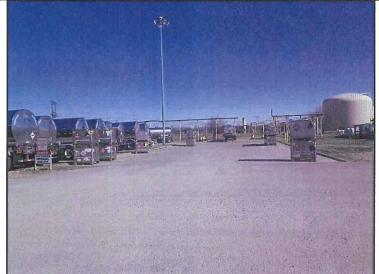
Attributes					
Photo Number	23				
File Name	RIMG0111.JPG				
Date/Time	3/8/2018 2:16:43 PM				
Photographer	L. Goodnight				
Description	Building 18 less-than- 90-day area
